SOIL SHORING PROJECT EXPERIENCE

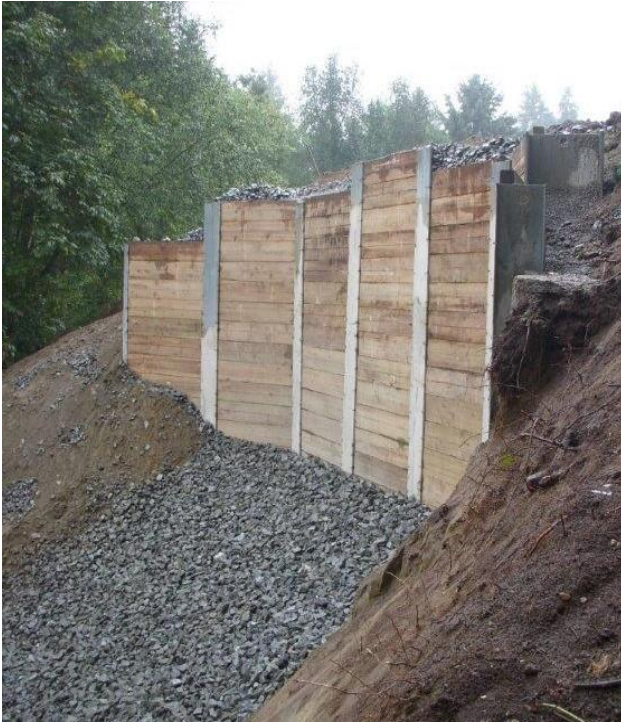
Heronfield Shoring Stabilization – Kirkland, WA

An unstable hillside required the installation of a 20-foot tall permanent shoring wall. The wall was constructed with pressure treated wood lagging spanning to cantilevered soldier piles.

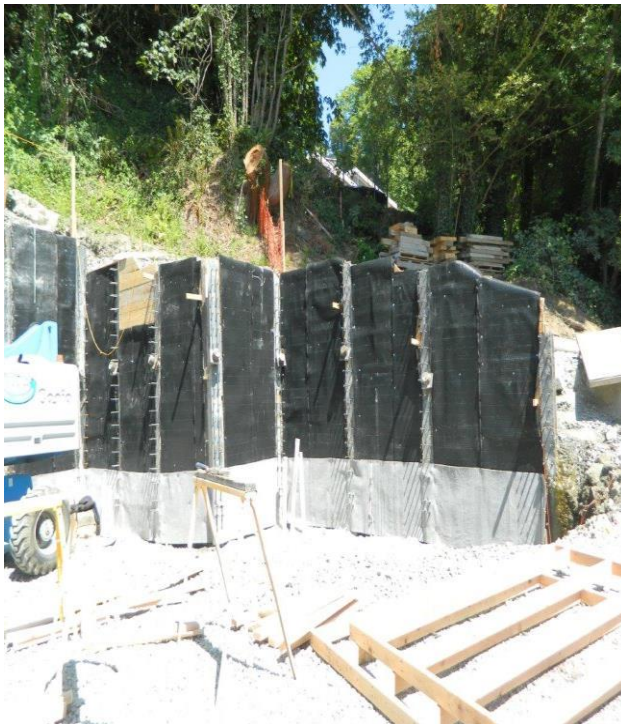
Private Residence – Mercer Island, WA

This temporary shoring wall consists of wood lagging spanning to soldier piles with a single row of tiebacks to support the construction of a single-family residence. The maximum shoring wall height was 25 feet. A reinforced concrete wall was constructed directly against the exposed face of the soldier pile wall to form the permanent basement wall of the home.

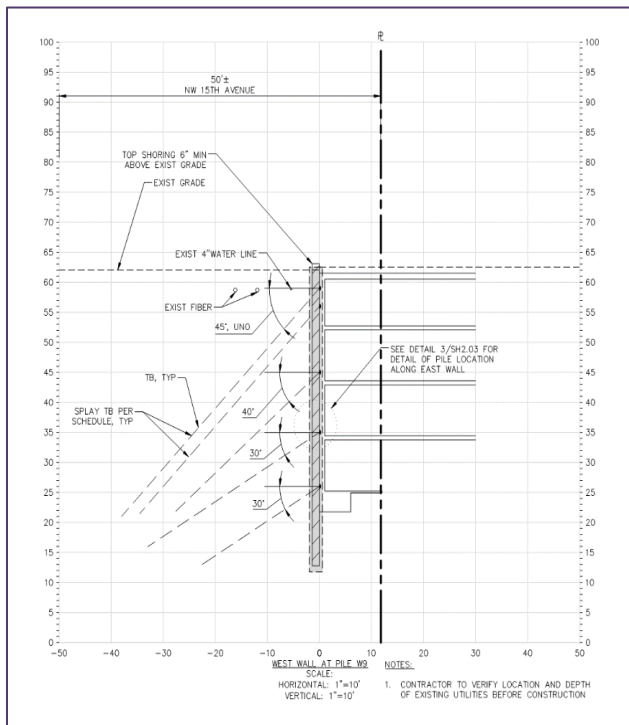
Mixed-Use Office Building - Portland, WA

This project consisted of temporary shoring for a 15-story mixed-use building with three levels of below-grade parking. The shoring consists of augured soldier piles with multiple rows of tiebacks. Tight property line constraints and adjacent utility placement required variable rake and plunge angles of the tiebacks.

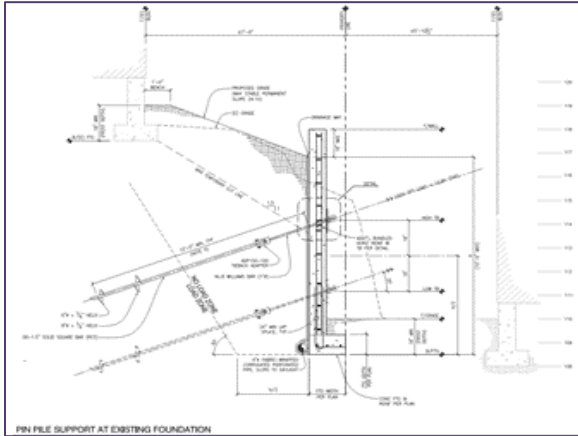
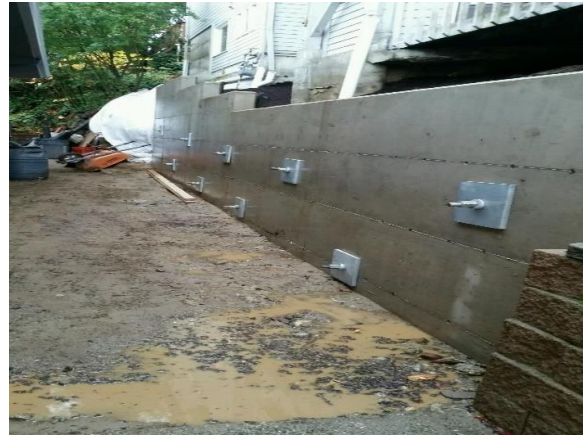
Private Residence – Seattle, WA

Permanent shoring adjacent to an existing single-family home was required to stabilize a steep slope. The shoring consisted of a tieback cast-in-place concrete wall.

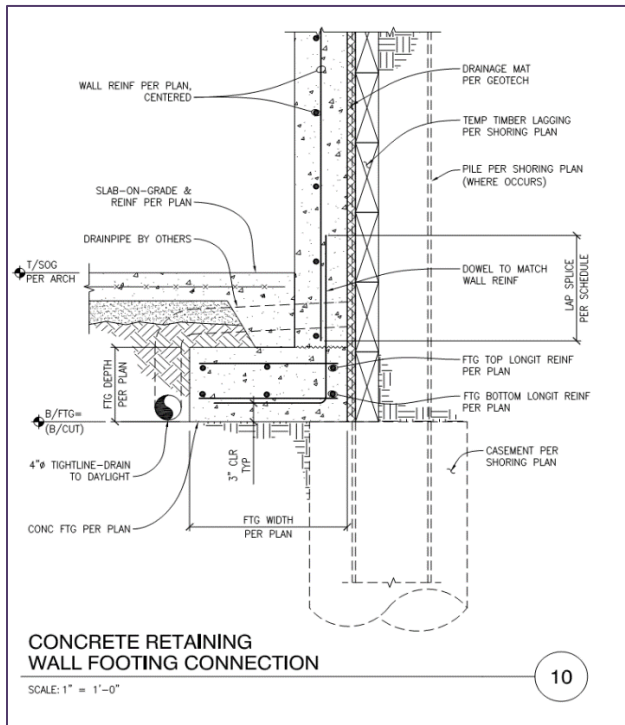
Private Residence Shoring – Bellevue, WA

Temporary shoring was installed on three sides of a private residence to enable the placement of permanent concrete retaining walls. The site had exceptionally steep slopes from the top of the wall, which created high surcharge design loading

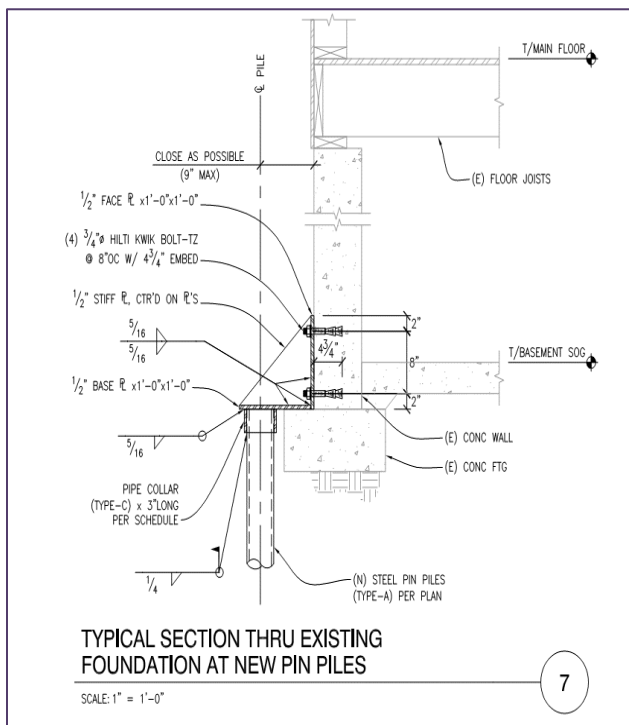
Private Residence Shoring – Seattle, WA

This permanent shoring consists of a cantilevered soldier pile wall and underpinning support for the existing foundation. This project was necessitated by a shallow slope stability failure which partially undermined the footing. The intent of the design was to both stabilize the hill side and provide additional vertical support of the house.
